# REACTIVE SILICATE COATINGS FOR PROTECTING AND BONDING REINFORCING STEEL IN CEMENT-BASED COMPOSITES

S. W. Morefield\*, V. F. Hock\*, C. A. Weiss, Jr.‡, P. G. Malone‡, and  
M. L. Koenigstein§

\*US Army Engineer Research and Development Center, Construction Engineering Research Laboratory,  
Champaign, IL 61820

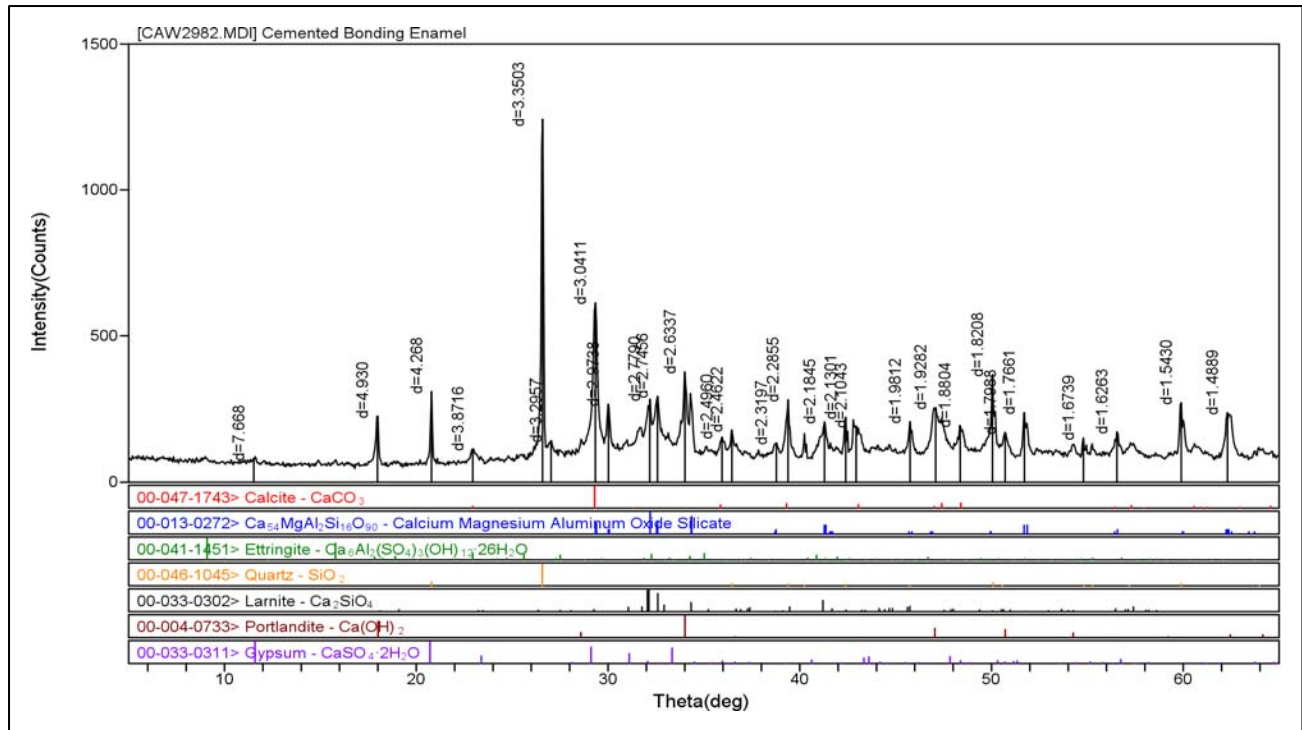
Fig. 8. X-ray diffraction pattern for coating with adhering mortar.

X-ray diffraction patterns obtained from ground samples of the unhydrated bonding enamel (Fig. 6), the hydrated enamel (Fig. 7) and enamel recovered from

under the adhering mortar (Fig. 8) are shown below. The pattern from the unhydrated enamel shows unreacted cement and the portland cement contains all of the crystalline phases that would be associated with cement. None were altered in the firing process even though the enameling process requires that the material be maintained at approximately 850 °C for 5 to 20 minutes. Even gypsum (calcium sulfate dihydrate) did not decompose although it should lose attached water molecules at temperatures above 70 °C (Deer, Howie and Zussman, 1962) and significantly dehydrate above 123 °C (Prasad, Pradhan and Gowd, 2001). The kinetics of dehydration are slow enough that all of the cement components survive. The sample of hydrated coated (Fig. 7) shows prominent peaks for calcite and ettringite indicating normal hydration reaction have occurred. The pattern for the coating with the adhering mortar shows added peak for quartz and both calcite and portlandite. This pattern is typical for hardened mortar made with quartz sand as fine aggregate.

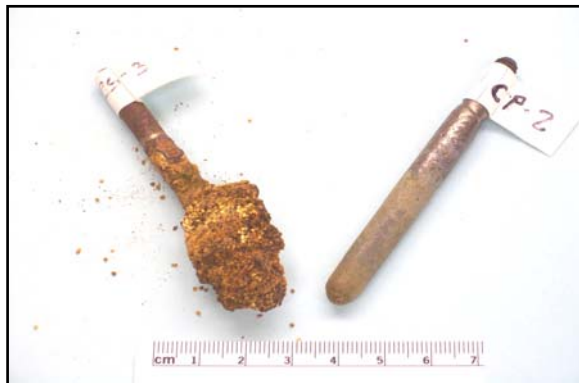
Fig. 9. Corrosion observed to uncoated (left) and coated test rods after 40-day exposure to a 3.5% NaCl solution. The dull surface of the coated rod is produced when the portland cement embedded in the glass hydrated.

Figure 9 shows the result of exposure of coated and uncoated steel test rods to a dilute solution for 40 days. The uncoated rod is badly corroded. The coated rod contained portland cement embedded in the enamel and the cement hydrated to produce a slightly rough surface. The glass-cement coating prevented contact with the salt solution and no corrosion occurred. Corrosion could only be produced if the enamel was purposely removed by drilling through the coating to expose the metal. When moistened the surface of the coating was alkaline (pH ≈ 12) when tested using colorimetric techniques.
